AFRL-ML-WP-TR-2004-4279

**RESEARCH AND DEVELOPMENT
(R&D) ON ADVANCED
NONSTRUCTURAL MATERIALS**

**Delivery Order 0001: Study of Hydraulic
System Component Storage with Operational
and Rust-Inhibited Hydraulic Fluids**

Study of Hydraulic System Component Storage with Operational and Rust-Inhibited Hydraulic Fluids

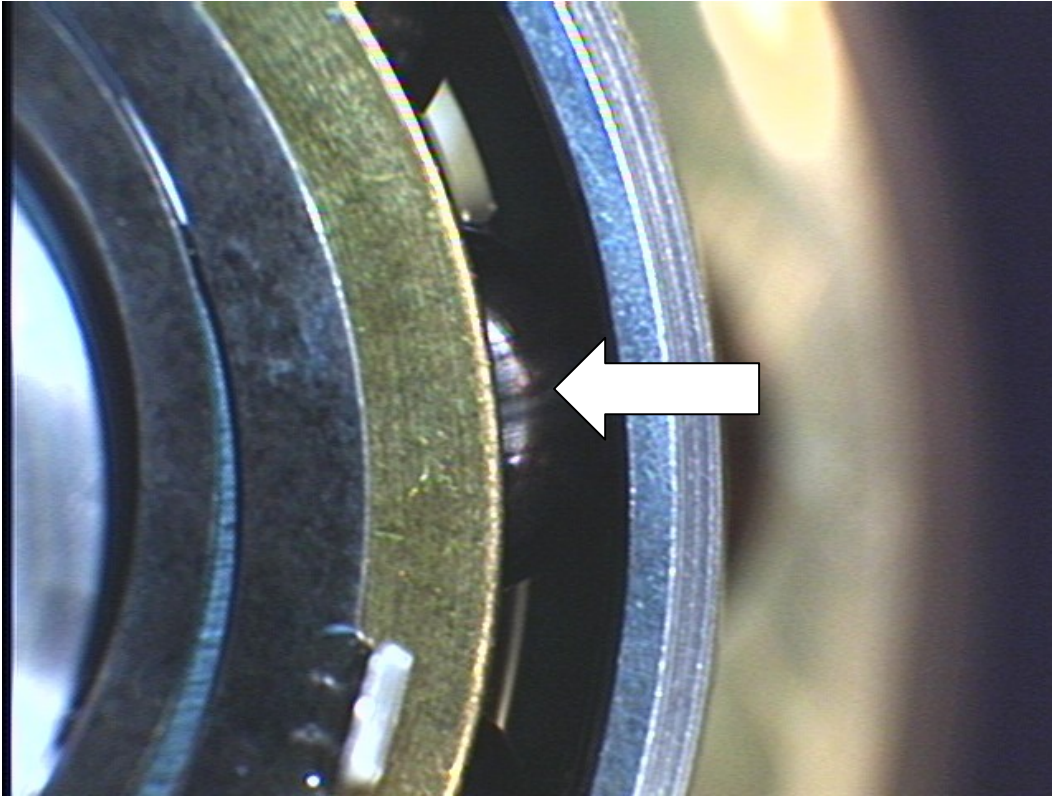
The next picture is a close up of the main shaft bearing. Stripes were observed on the ball bearing. This phenomenon only occurred with this fluid.

Most of the parts appeared identical to pretest inspection. Red gel and colorful banded staining was found on the balls of the main shaft bearing. The pattern created appears to involve the bearing cage. The photographs are shown in Appendix H. The bearing exhibited slight hesitation to free rotation of the outer race when turned by hand. No other abnormal features were observed. The pump was reassembled to proper specifications including lock-wire installation and refilled for further storage.

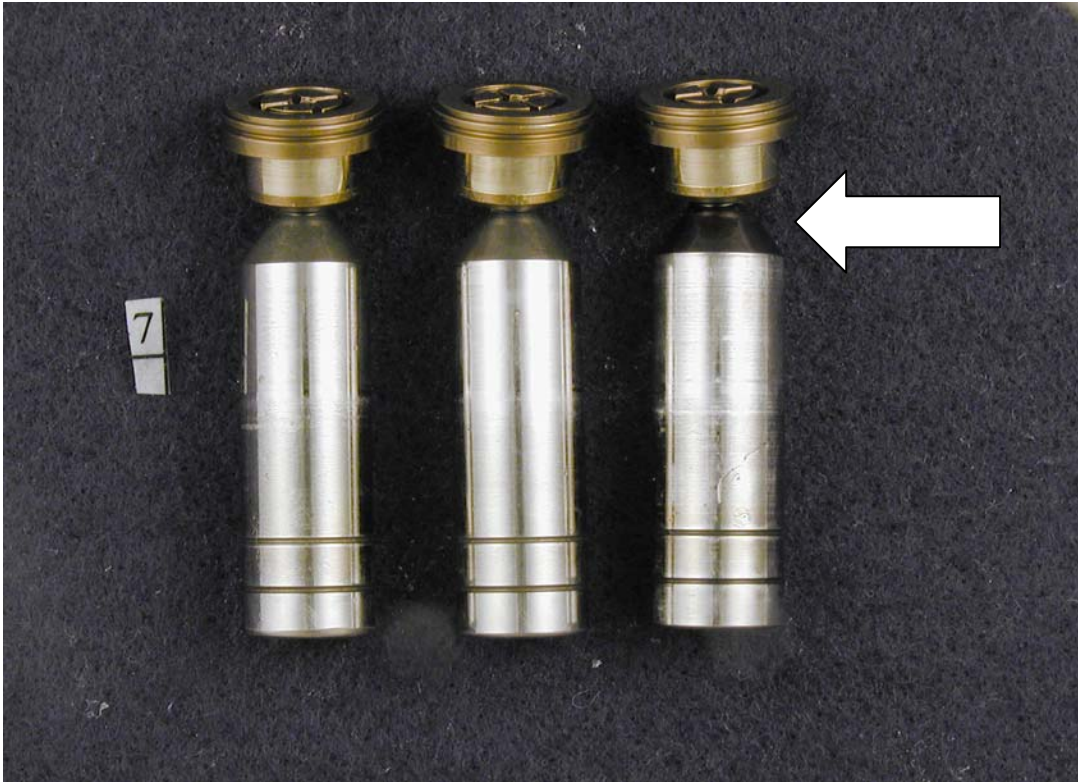
Below is an enlarged image of the pistons. The tarnish on the tapered section of the pistons is evident.

Most of the parts appeared in good condition and free of corrosion. The main shaft bearing had deteriorated in rolling smoothness, and definite rotational roughness was easily felt. The appearance of the bearing balls has changed since the previous year, from colorful banding on a reduced luster surface to an even, colorless dullness without differentiation over the complete ball surface. The tapered area above the gimbal joint of the piston/shoe assembly had a ruddy tarnish not seen before in this pump. This area never contacts other metals, but is exposed only to fluid. No other abnormal features were observed. Photographs are in Appendix I. The pump was reassembled to proper specifications including lock-wire installation and refilled for further storage.
